Build the Right Barrier

Durable connections are the most important factor in a high-performance air-barrier system

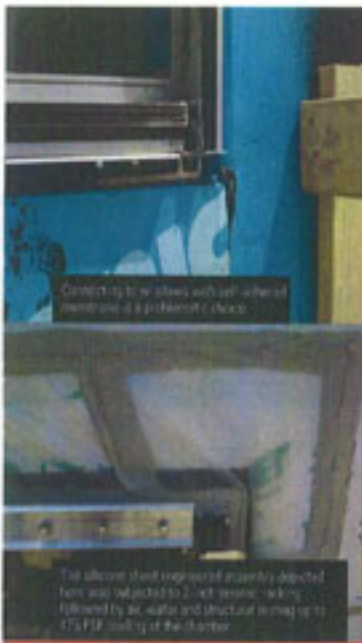
Connecting to low-stress walls with self-adhered membrane is a problematic choice.

The silicone sheet membrane assembly depicted here was subjected to 2-year seismic testing followed by air, water and structural loading up to 175 PSF loading of the diaphragm.

To give proof of the superiority of silicone sheets, testers have successfully integrated the attachments to glazing assemblies and documented their success by way of performance testing consistent with ASTM E2357-05. (The test even used actual window assemblies in lieu of plywood.)

The test also assessed an assembly's potential for failure when experiencing seismic movement of as much as 2 inches (AAMA 501.4 Modified), followed by air

infiltration, static water, dynamic water and structural testing to destruction at 175-psf load per ASTM E330. Pre-molded corners assured integrity at critical stress areas.

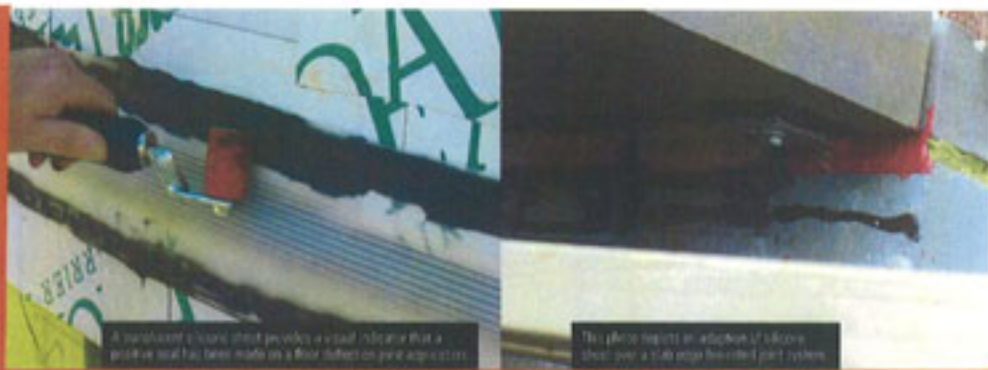
A translucent silicone sheet provides a visual indicator that a positive seal has been made on a floor defect or joint application.

This photo reports on adhesion of silicone sheet over a slab edge finished joint system.

The silicone-sheet assembly and low-modulus silicone sealant also offer the best solution for handling floor deflection joints. Both components marry together to form a high-movement joint seal.
